Unilateral Horizontally Impacted Maxillary Canine and First Premolar Treated with a Double Archwire Technique

Abstract: A patient with a unilateral horizontally impacted upper left canine and first premolar was treated orthodontically. The use of a double archwire technique achieved the desired treatment goals. We discuss the problems associated with impacted maxillary canines and first premolars and the biomechanical interventions used for this patient. (*Angle Orthod* 2006;76: 502–509.)

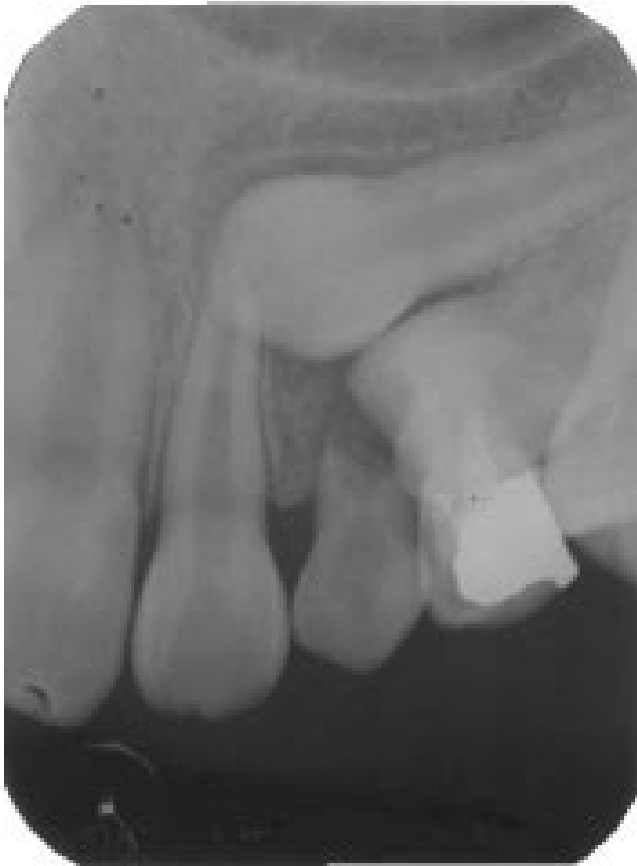
FIGURE 3. Pretreatment periapical radiograph of the left upper canine-premolar region. Note that the root axes of both impacted teeth were quite parallel to the occlusal plane.

A radiographic examination revealed that the maxillary left canine was in a horizontal position with its crown tip near the apex of the lateral incisor and its root positioned above the root apices of the posterior teeth (Figure 2). The maxillary left first premolar was located horizontally under the left canine with its crown above the root tip of the retained maxillary left deciduous first molar and its root superimposed over the roots of the second premolar and first molar (Figure 3). A vertical tube shift technique with periapical radio-

However, the root axis looked acceptable when examined on a periapical radiograph (Figure 3), and the axes of the clinical crowns of the upper lateral incisors looked normal as well. Considering that the root tip of the upper right lateral incisor was located close to the impacted canine tip, distal tipping of the lateral incisor root might have caused an accidental contact of the roots. Therefore, it was decided to maintain the original root axis of the lateral incisors. In the posttreatment panoramic radiograph, the axis of the upper lateral incisor roots appears unchanged (Figure 10).

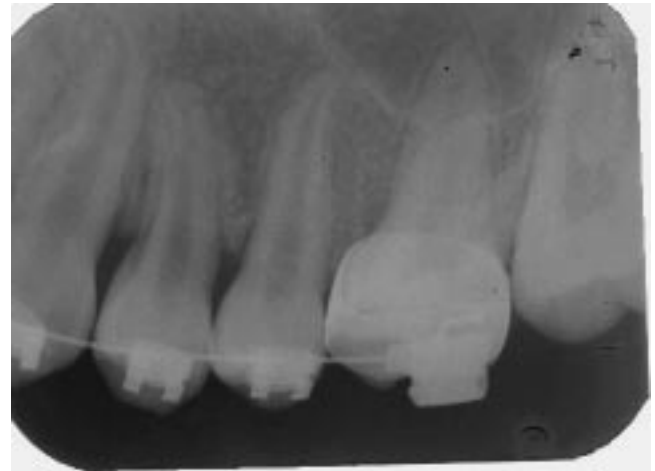
FIGURE 8. Periapical radiograph shows the roots of first premolar and canine well aligned.

Detailing bends were made on the 0.016-inch stainless steel main archwire to adjust the alignment of the teeth. A periapical radiograph showed satisfactory progress in the eruption of both impacted teeth (Figure 8). The final 0.016 × 0.022-inch stainless steel archwire was placed to adjust the root torque. An excessive buccal root torque for overcorrection was applied on the upper left canine to prevent relapse. Because an acceptable occlusion with adequate root dispersion had been achieved, the fixed appliance was removed (Figure 9). The total treatment time for this patient was 20 months. Retention was established with a maxillary removable retainer.
